Investigation of failure of migrating juveniles to cross Tewkesbury weir

E. J. P. Wood

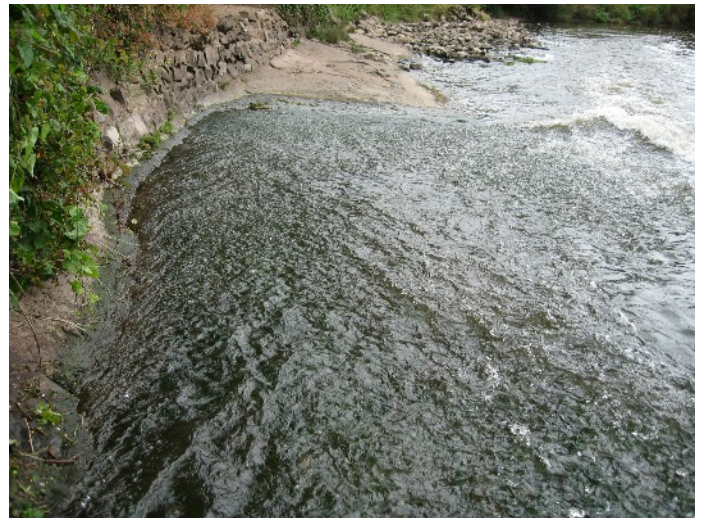
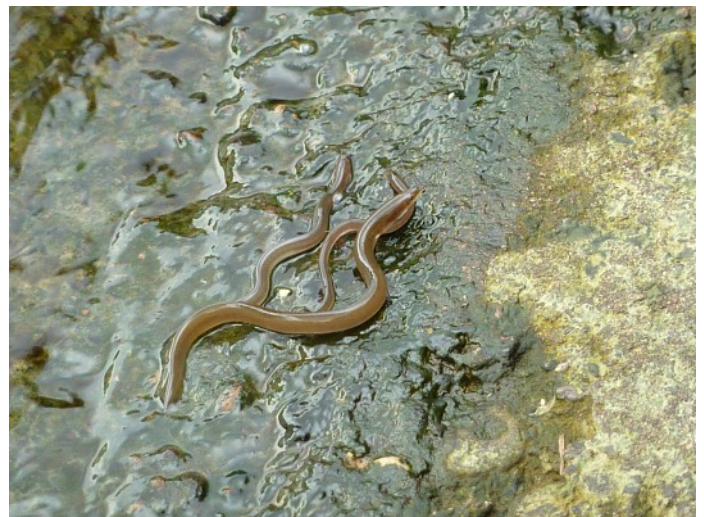
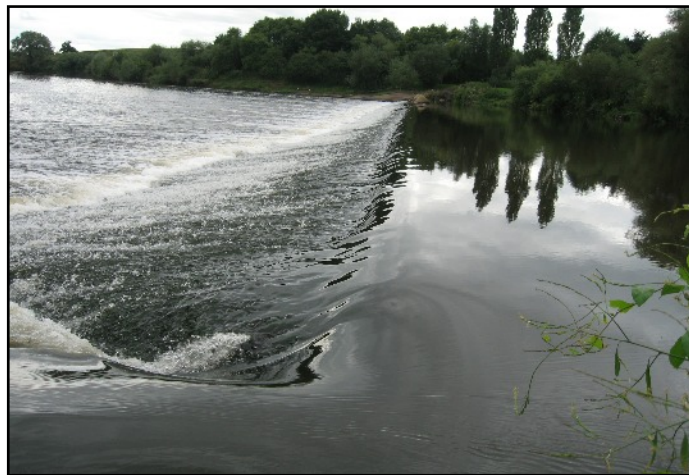
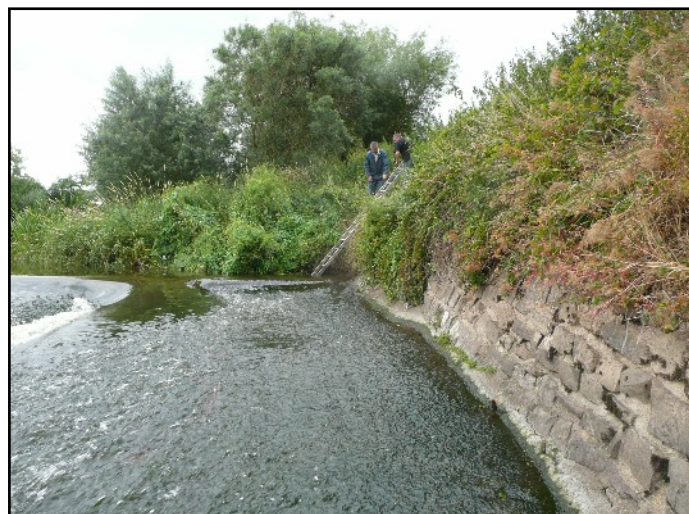
The weir is approximately 1.5 metres in height with a fish pass cut into the top of the weir on the right hand side creating a very strong flow of water across the face of the weir. At the base of the weir there is a gently sloping surface where a wide shallow slow moving wet interface exists between the bank and the rapid spillway.

Moving towards the crest of the weir this interface becomes steeper and narrower and offers little protection from the rapidly flowing spillway. Some 7 meters from the top of the weir this interface it is obstructed by a clay land drain forming a vertical surface with no interface.

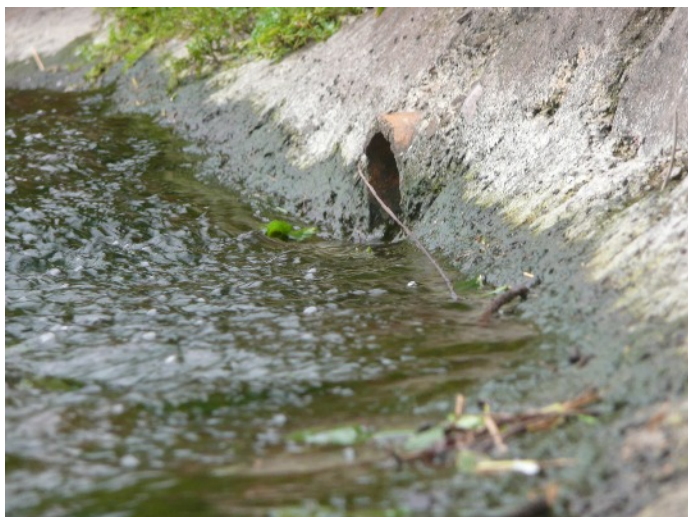
At the time the migration was observed river flows were such that an additional obstruction in the form of a small standing wave was created opposite the drainage

pipe. Between this drain and the crest of the weir the gradients on the side of the weir are much steeper. The interface is very much narrower, the surface is damp but free of water.

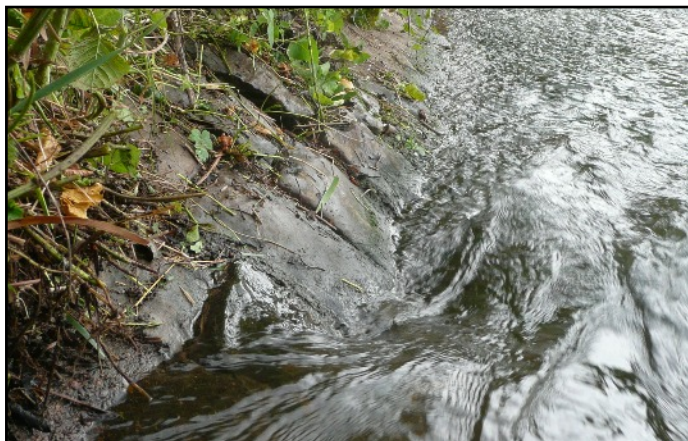
At the crest there is no interface just a very rapid stream of water over a distance of approximately 0.3 M.

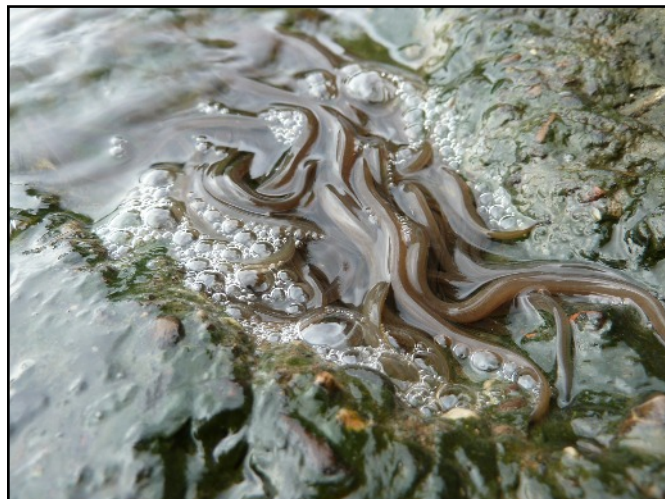
Red Arrow.

Marks approximate limit of competent ascent

The narrow migratory interface, the steep gradients and rapid water velocities make the weir impassable to the majority of the juvenile eel population. The conditions select the passage of juveniles less than 2 gm. The construction of permanent passes that are resilient and maintenance free is a particularly demanding engineering task. Perhaps alternatives should be examined e.g. specialised lower cost temporary structures that facilitate the passage of eels at designated times of the year.

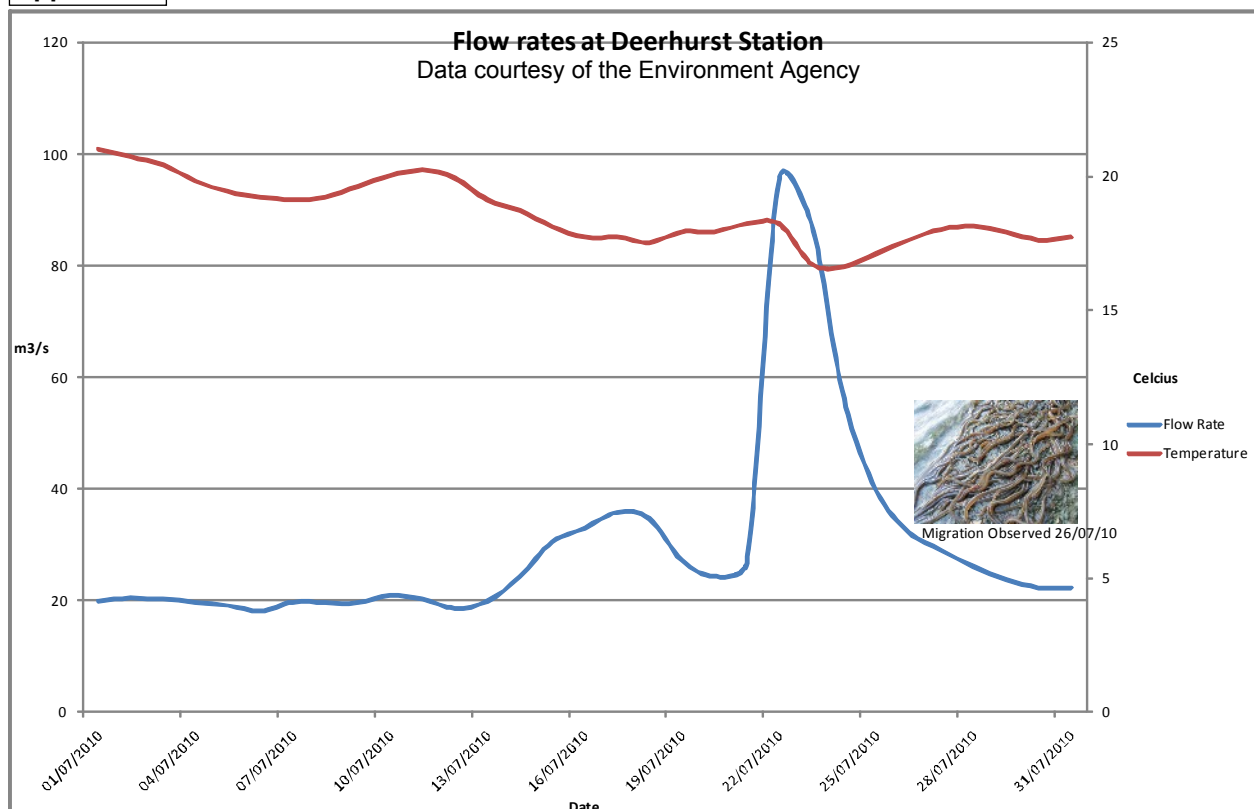
Appendix II

The Tewkesbury weir defines the upper tidal limit of the river. Only the largest of the spring tides can flow across the weir. During the juvenile migration period in the summer there would be some 15-25 tides that would level or flow the weir. Appendix 1. Juvenile eels must be able to traverse this barrier if they are to access the middle, upper Severn and the Avon system. While the weir is passable in flood conditions and some spring tides it is unlikely that these conditions will coincide with the active synchronous migration of juvenile eels. The synchronous migration is probably associated with increased summer flows. Appendix II.
